COASTAL DESIGN AND TSUNAMI MITIGATION FOR SHELTER/HOUSE RECONSTRUCTION ON THE WEST COAST ACEH

Mr Frank Wilkinson,
Director, FL Wilkinson and Associates Canberra Australia
Seconded to UNHCR (Indonesia) by RedR (Australia)
frankwilkinson@bigpond.com

ABSTRACT: The author was commissioned by RedR Australia to work with UNHCR to investigate and report on the provision of coastal design and tsunami mitigation requirements for planning of a program of shelter/house reconstruction along the west coast of Aceh Province. Inspections by land and air of a number of settlements and town sites along the west coast of Aceh were made and discussions were held with survivors who had witnessed the progress of the tsunami across the coastline and over the land. A summary of these observations are presented together with conclusions regarding the wave height, run-up, inundation and the effect these waves had on a variety of structures including houses, roads and bridges. A simple numerical model, calibrated against the field observations, was used to estimate the water velocities and forces that occurred. The problems of warning systems and escape options are addressed together with the probability

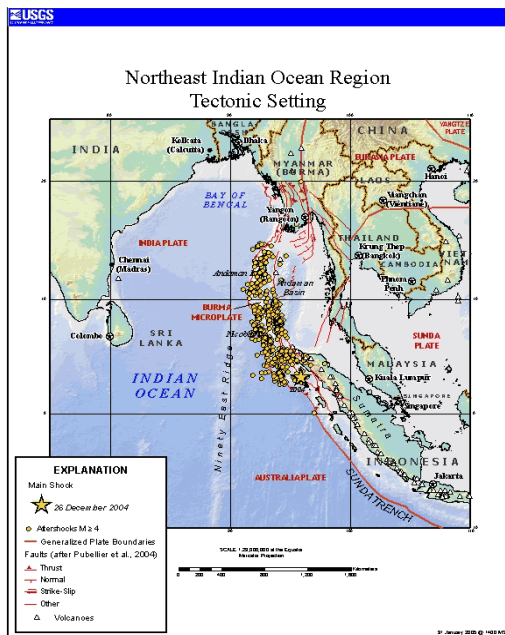
Fig. 1 Earthquake Rupture Zone.

The fault zone that runs to the west of Sumatra is one of the more active fault zones. Numerous earthquakes have occurred in that area and many have produced tsunamis in the past. The 26 December 2004 earthquake resulted in a fault rupture zone, uplifted by several metres, and covering an area 150 km. wide that extended 1300 km. to the Andaman Island, (see Fig. 1)[1]. Following the earthquake, HMS Scott a British Navy Hydrographical Survey Vessel, undertook a survey of the seabed west of Aceh. Figure 2[2] is from a presentation of this survey and shows the positions of the epicentre (yellow dot), the area of maximum seabed movement (red dot) 280 km south-southeast of Banda Aceh. This survey also showed up many landslides and slips occurred in the trench to the north of the epicentre and area of maximum seabed movement.

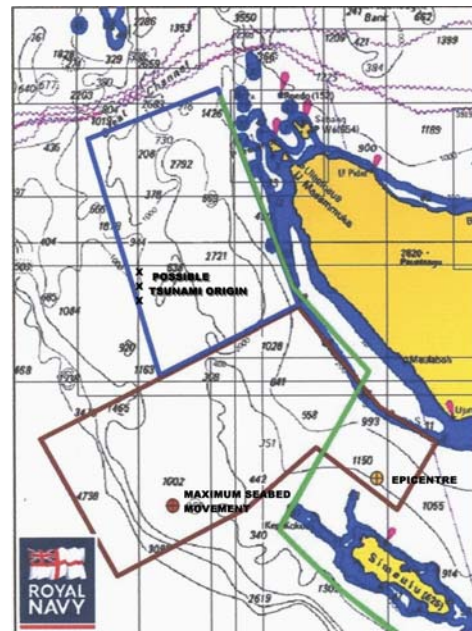
Fig. 2 HMS Scott Hydrographical Survey

Eyewitnesses advised that the earthquake lasted 15 minutes and that the time interval from the start of the earthquake to the arrival of the first wave front of the tsunami was about 35 minutes at Banda Aceh, 25 minutes at Calang and 50 minutes at Meulaboh. The source of the tsunami is unclear at present. However, based on triangulation from the above arrival times for the first wave, a possible source is an area west of Calang as shown on Figure 2. This is near the area of landslides and slips reported in the trench north of the epicentre by HMS Scott.

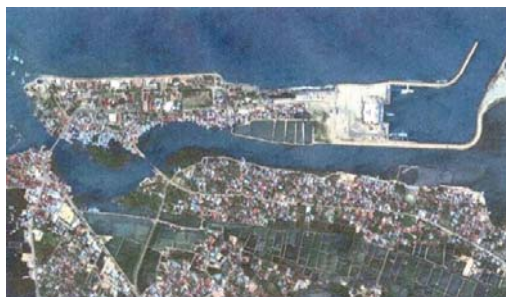
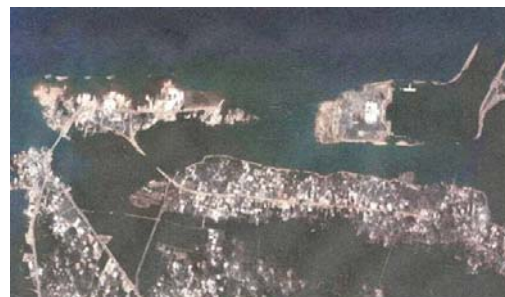
Fig. 3a Banda Aceh Uleele Before Tsunami

Fig. 3b Banda Aceh Uleele After Tsunami

At Uleele, a coastal suburb of Banda Aceh, the 10-metre high tsunami resulted in complete foreshore destruction and extensive coastal erosion and destroyed the port (see Fig. 3a and 3b). The housing at Uleele was expensive two or more storey brick construction constructed on a coastal spit and it was destroyed (see Fig. 4). However, adjacent to this area of destruction, a mosque survived the tsunami wave with minor earthquake damage to the upper floor awning and minor tsunami damage to the roof (see Fig 5). This indicated that the tsunami wave was 6 to 7 metres above the ground level (approximately 8 to 9 metres above sea level).

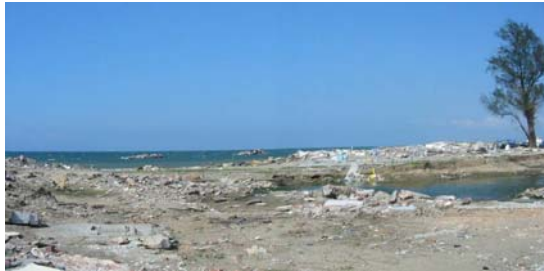
Fig. 4 Foreshore at Uleele, Banda Aceh

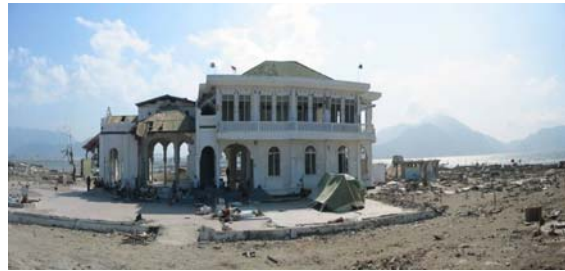
Fig. 5 Mosque at Uleele, Banda Aceh

Just about every mosque along the west coast survived the tsunami with minimal damage. It is believed this occurred for two reasons. Firstly, the structures are more open than the normal house and are subjected to lesser wave forces and secondly mosques are built to a higher standard of design and construction than housing and the correct quantity of steel and cement was used in the reinforced concrete construction. This would suggest that structures properly designed and constructed in accordance with the Indonesian Building Code have a very good chance of surviving a tsunami and providing safe refuges.

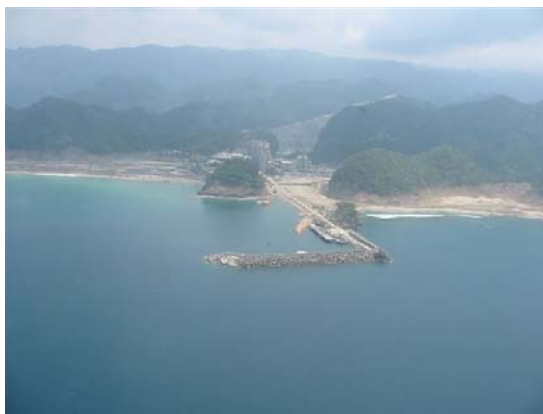
At Lhohnga, 10 km west of Banda Aceh the area was completely devastated by a wave of over 13 metres height, as estimated from stripped bark on trees. The run-up against the coastal hills near the cement plant was 35 metres[3]as measured from the trim line. All the housing that was on lower ground and within 6 km of the coast was demolished. The only remaining structures at Lhohnga were the mosque and the cement plant. At the cement plant harbour a 100-metre ship was capsized at the berth and the head of the tetrapod armour breakwater failed. The trim line where vegetation was stripped from the hills is seen in Fig. 6. Generally run-ups, as measured by the trim line were 10 to 15 metres 1 km from the foreshore. At 2 km from the shoreline, the trim line while still observable was reduced to < 5 metres.

Fig. 6 Lhoknga Cement Plant, Breakwater, Wharf, and Capsized Ship

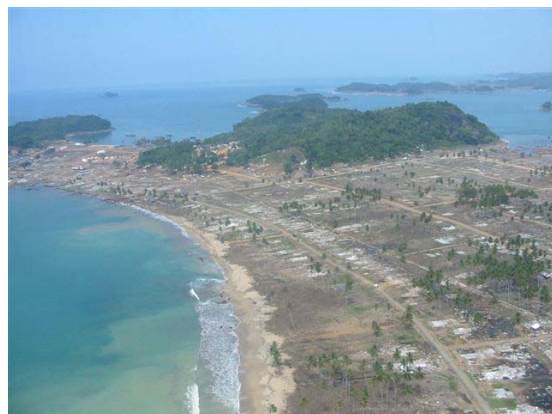
Fig. 7 Calang Peninsular

Calang, a district capital 100 km from Banda Aceh, is built on a peninsular on low-lying ground. The peninsular has three hills spaced such that the tsunami approached the town from three directions (see Fig. 7). This resulted in amplification of the water level in areas where the wave fronts met resulting in maximum wave run-up of up to 25 metres, as observed from the trim line. In many areas, the trim line was in excess of 20 metres

Eyewitness advised that about 10 minutes after the earthquake had ended the water retreated from the shore and people on motor bikes drove round the town yelling that the big wave was coming and telling people to escape to the hills. With in five minutes water started to enter the road at the base of the hills while residents were running to escape the wave. However, the line of houses at the base of the hill stopped access directly to the hill and the one road was the only way up the hill to safety. The road was full of people, there was a traffic jam of people, bikes, and cars and most people were not able to reach safety including some that lived only 100 metres from the point where the road started ascending the hill. Official figures show that 90% of the population of 9,000 lost their lives in the tsunami. The people of Calang were aware of the danger of the tsunami but the lack of town planning controls resulted in shops and housing being built so that the direct access to the safety of the hills was blocked.

It is understood that the policy now allows people to rebuild in all areas. However, government will commence an education program to allow people to understand the risks and the opportunities available to reduce the risks. The people will then be given 10 years to decide whether they want to move to safer areas. This timing allows the Government to obtain land that is not presently available. In some cases the District Capitals such as Calang will be moved inland clear of any inundation.

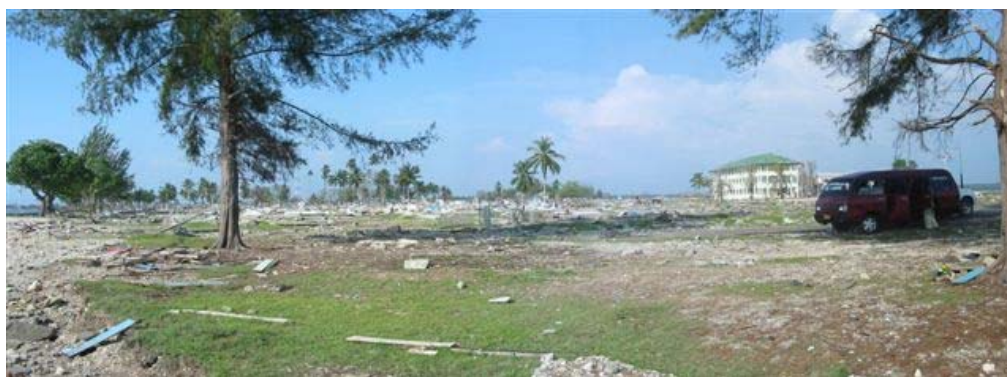
Fig. 8: Meulaboh Peninsular - Total destruction except for the Army headquarters

At Meulaboh, where the height of the tsunami wave was less than 5 metres, the penetration was about 2 km. with most brick buildings beyond 1.5 km. surviving with minimal damage. Considerable damage occurred in the first kilometre including destruction of the bridge and the nearly complete destruction of the army barracks on the peninsular (see Fig. 8). The only buildings remaining were the Headquarters Building and the Communication Building. Both these buildings were well-designed and constructed buildings.

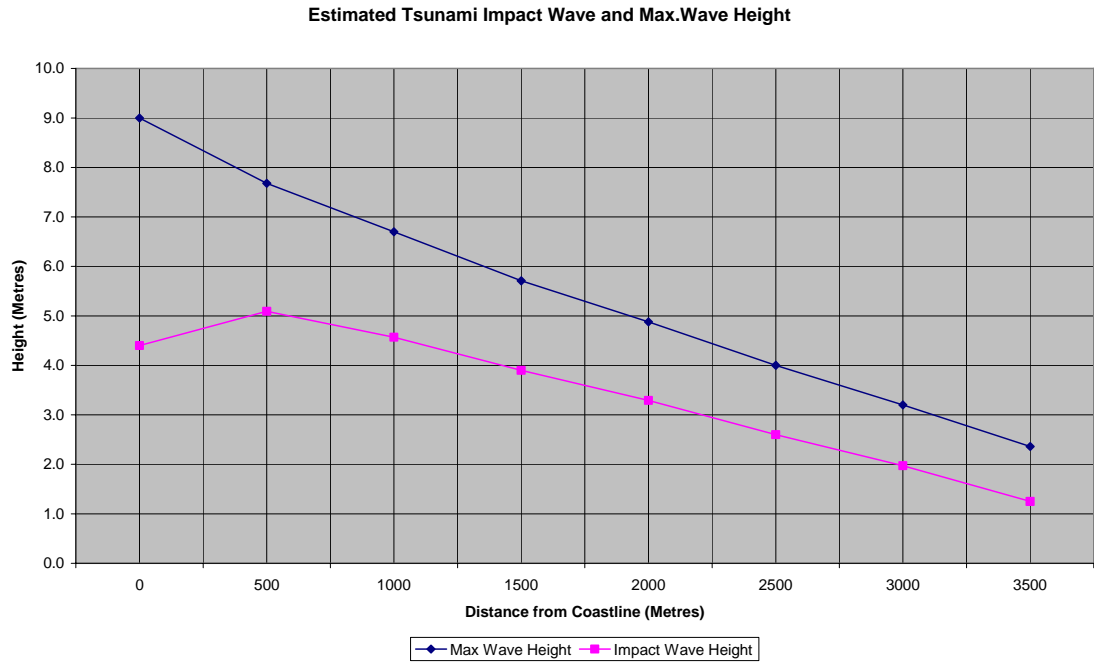
In order to estimate the wave velocities and forces that could be encountered from a 10-metre tsunami as it moved inland a simple two-dimensional numerical modeling study was undertaken. The study assumed that the land inshore from the coast was level, was 1 metre above sea level and the offshore seabed slope was 1:100. The model was calibrated against the observed tsunami wave heights that were measured in the field. This required adjustment of the model bed friction as buildings and trees were demolished with the progress of the wave. The model results obtained included water velocities and wave heights as the wave moved inland and the wave run-up for hills at 500 metre, 1 km., and 2 km. from the coastline.

The significant feature of the tsunami, as described by the eyewitnesses, is that it came as several, between three and five, broken wave fronts each higher than the previous one. The number of wave fronts appeared to be a function of the Tsunami height and the seabed slope. Eyewitnesses said that the first wave was slower and in some cases smaller and the impact wave was the second or third wave front. In this simple numerical model, there are no broken wave fronts and the impact or first wave is very steep and has the highest velocities. Despite this significant difference, it is considered that the model gives a reasonable representation for design purposes of the actual impact wave and velocities.

The results of modeling and field observations are at Fig. 9 for wave heights, Fig. 10 for water velocities, Table 1 for run-up and Table 2 for wave heights and velocities,. In most cases, the impact wave will cause the more severe design loading condition for one and two story housing, buildings, and structures while the maximum wave will be the design condition for larger buildings and structures. It is also the most important design criteria for defining safe areas.

Fig. 9: Estimated Wave Heights for the Impact Wave and the Maximum Wave

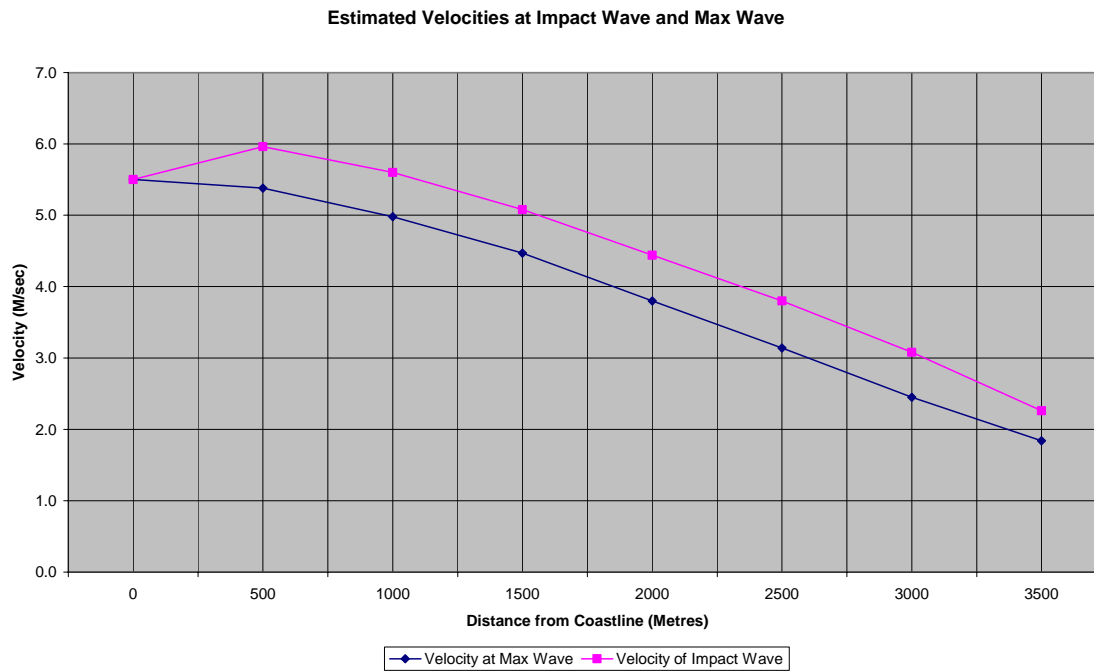
Fig. 10: Estimated Water Velocities for the Impact Wave and the Maximum Wave

The difference between the observed trim line and calculated run-up can be explained by the fact the velocities at 2 km inland are too low to strip the vegetation from the hills. It is believed that velocities in excess of 4.5 m/sec are required to strip the vegetation. The calculate run-up should be used to determine the elevation for safe areas on hills.

**The forces determined from these velocities should be doubled to allow for debris loading.*
